Elias Brookings School

Springfield, Mass

Emergency Damage Assessment

Re: Damage Investigation of Elias Brookings Expeditionary Learning Museum Magnet School
EDG Project Number: 2011-054

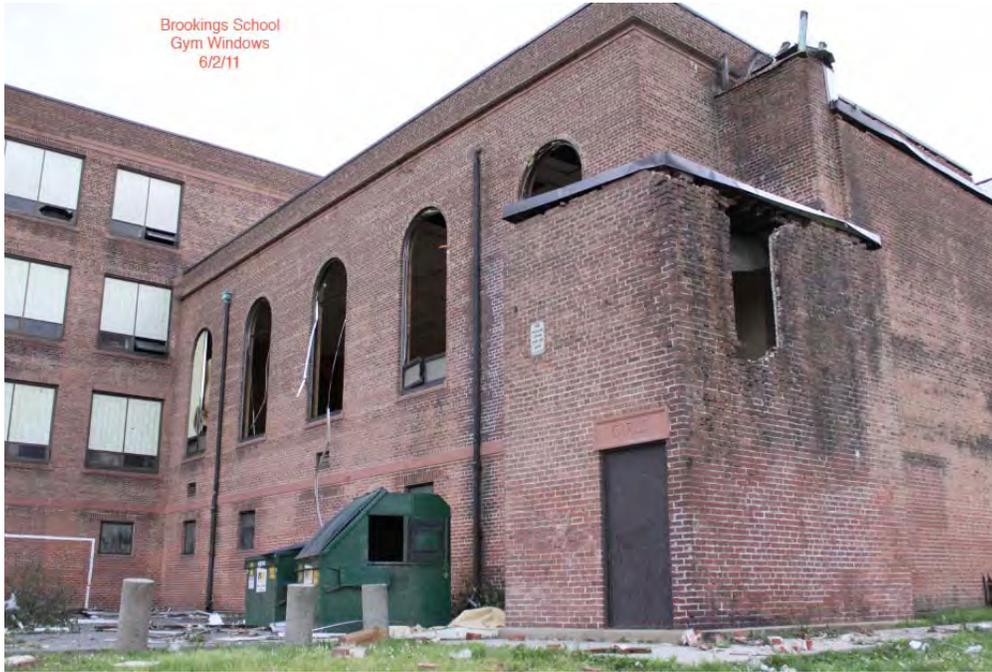
Blown out gymnasium windows and damaged single story addition.

Based on our preliminary assessment, we would recommend that the damaged single story addition to the east of the gymnasium be demolished and reconstructed since the bearing walls and the roof structure are structurally unstable; or, the structure should be temporarily stabilized until permanent repairs can be made. We would also recommend that the stair enclosure structure above the main roof be demolished and rebuilt. The parapet that is damaged should be stabilized and repaired.

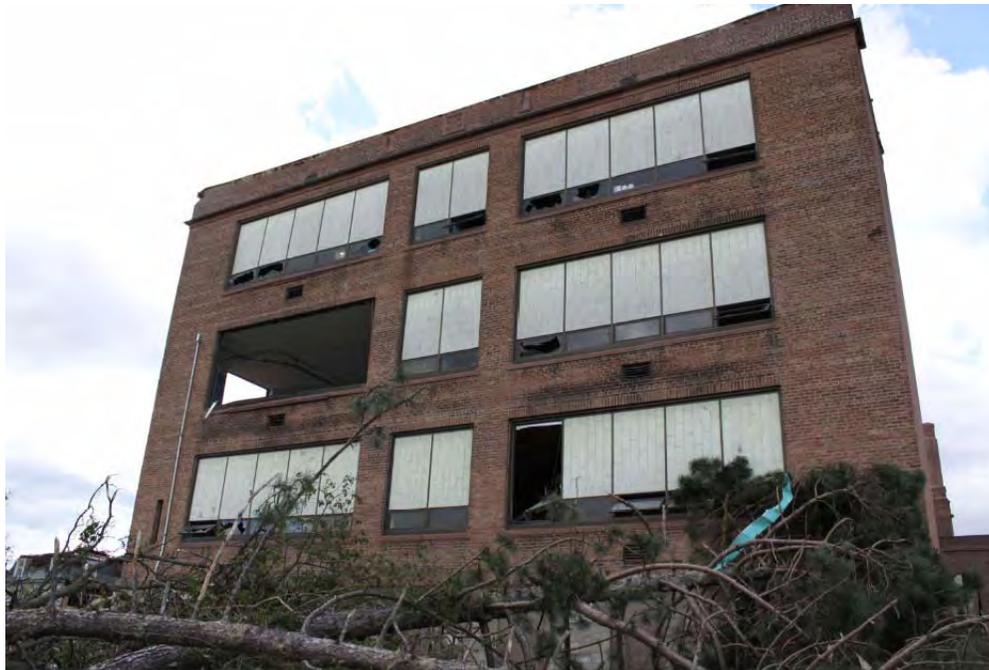
South elevation blown out window damage.

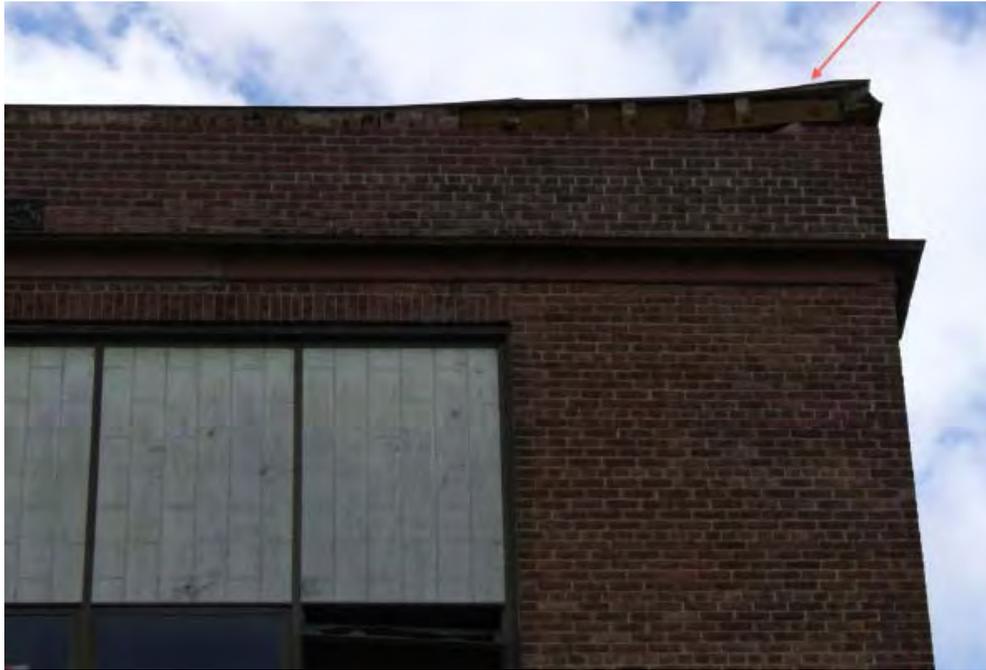
Typical roof coping damage.

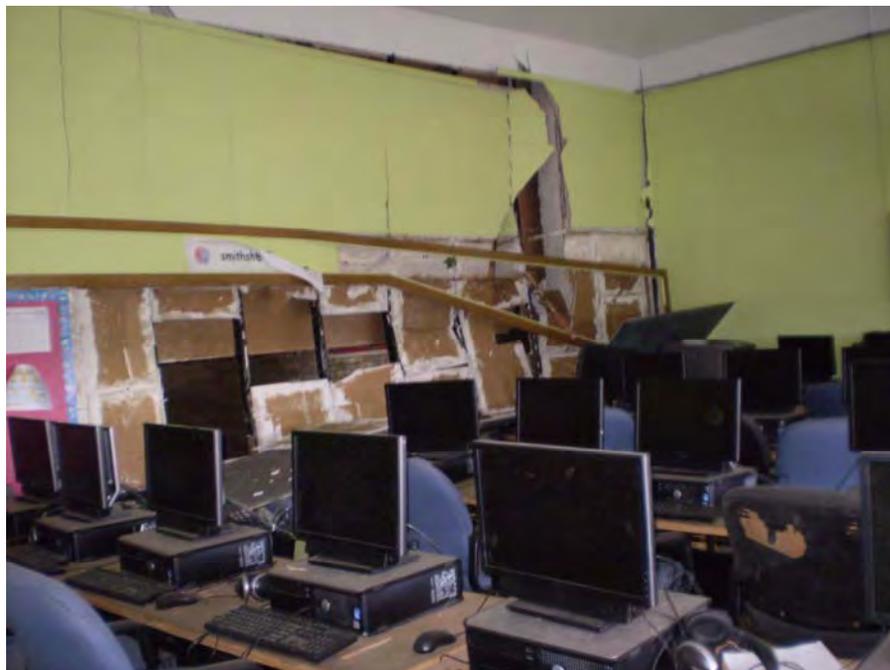
Blown out interior corridor wall.

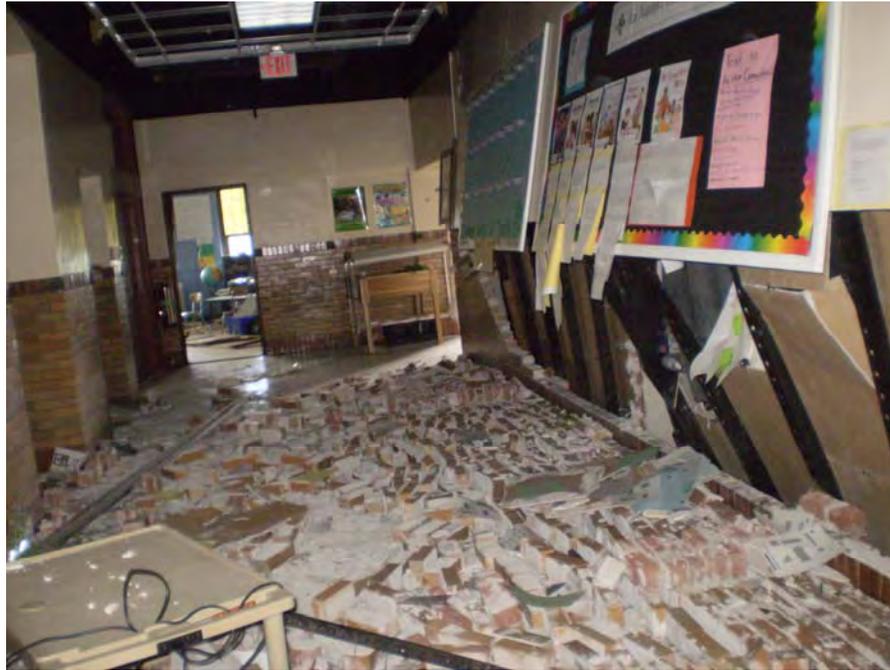
Blown out interior corridor wall.

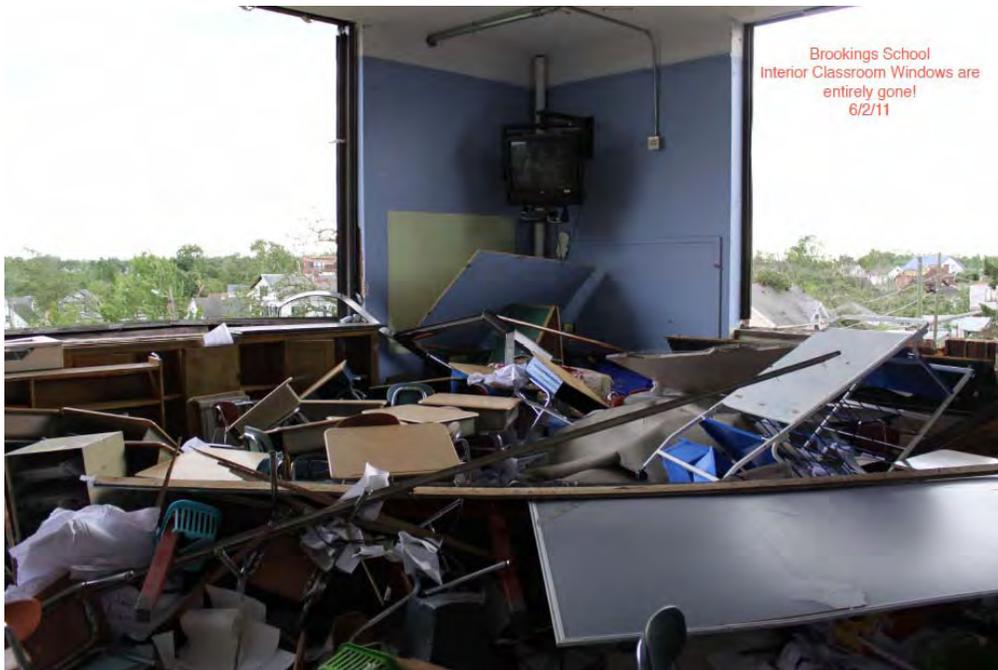
Blown out windows at south and west walls.

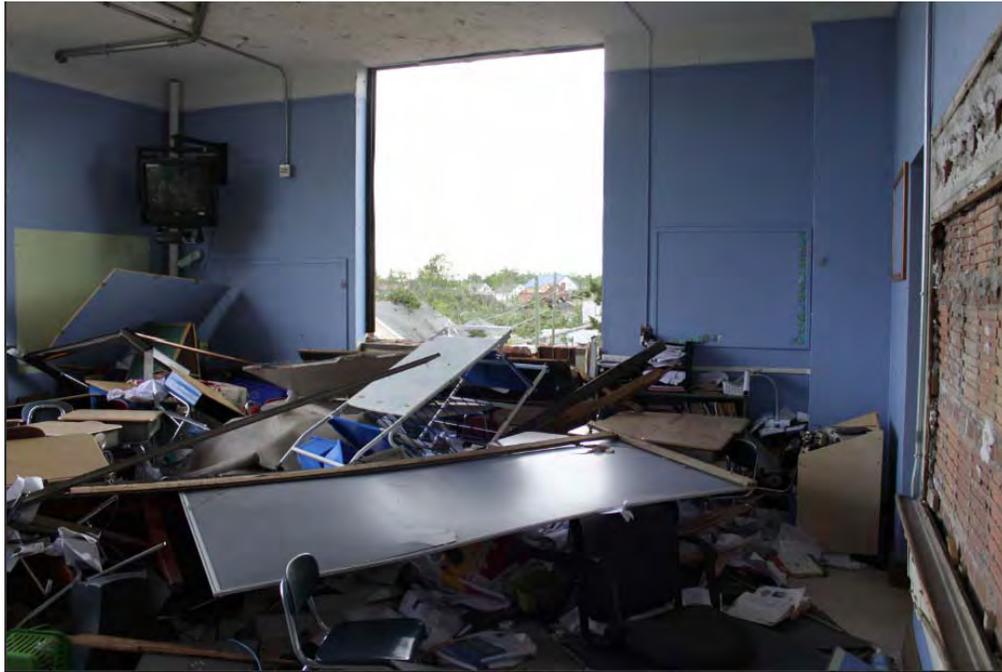
Blown out window at south facing wall.

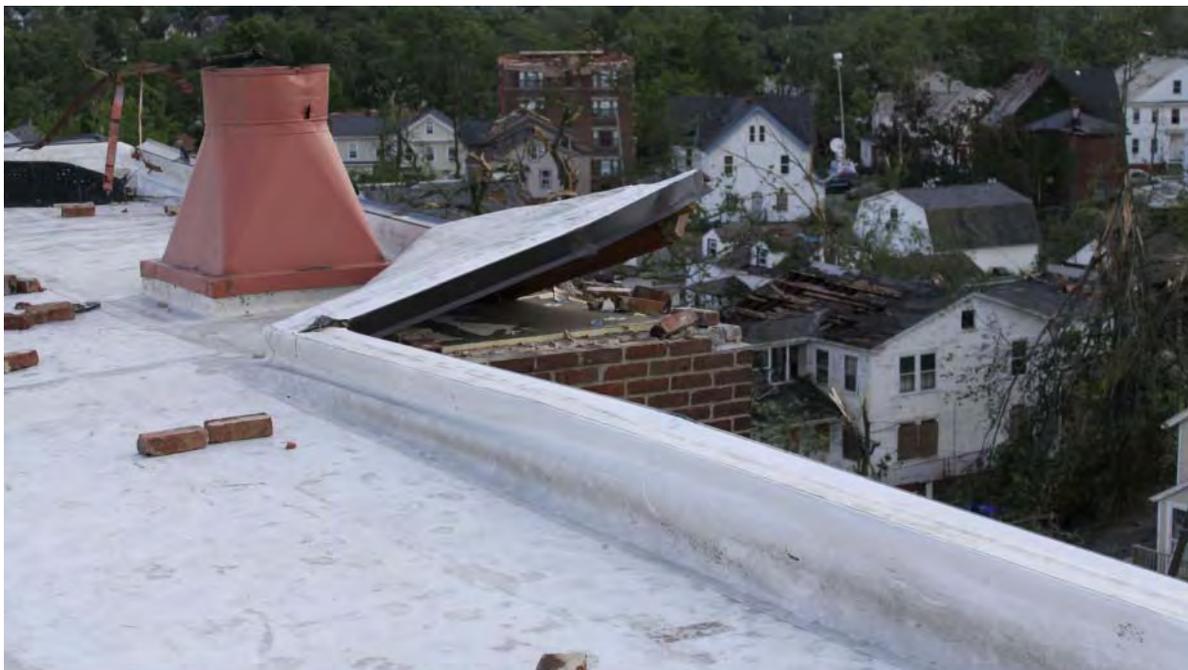
Damaged roof coping and top of masonry wall damage.

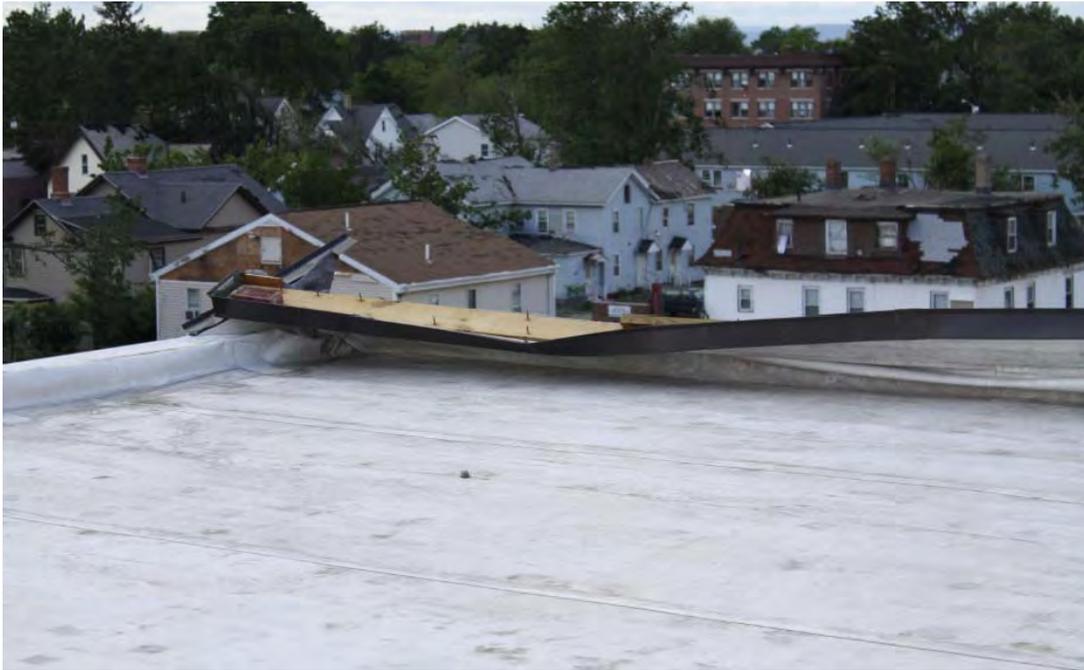
Damaged roof coping.

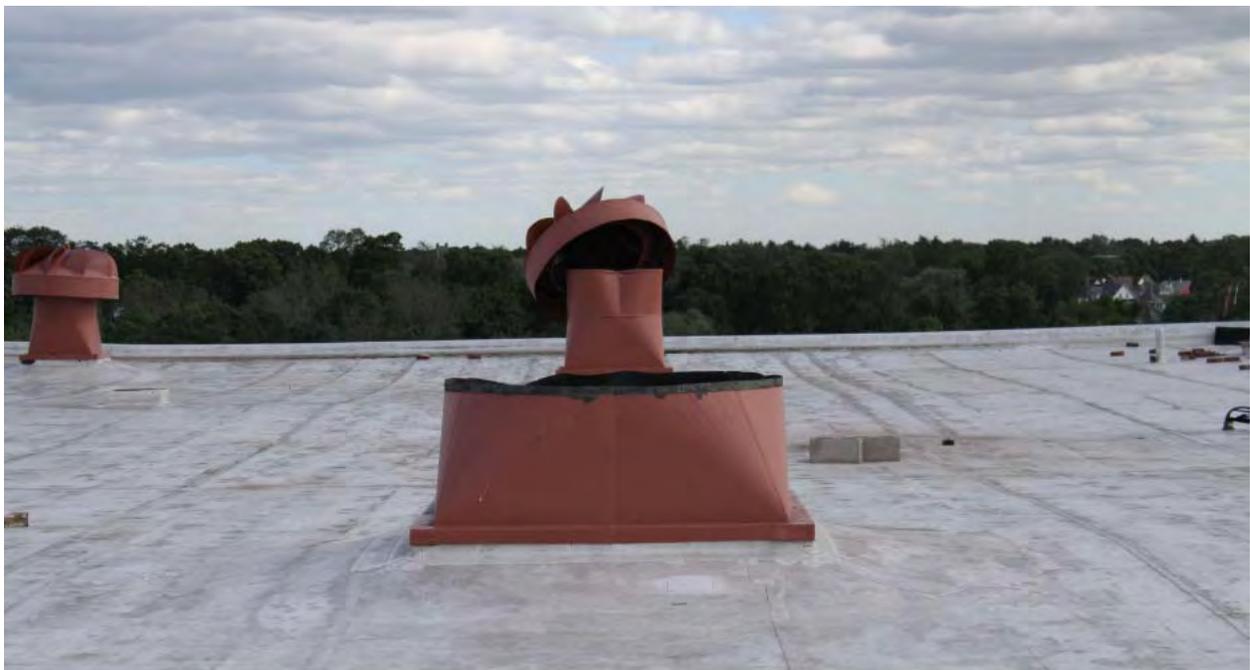
Damaged roof fans and detached/ballooned roof membrane.

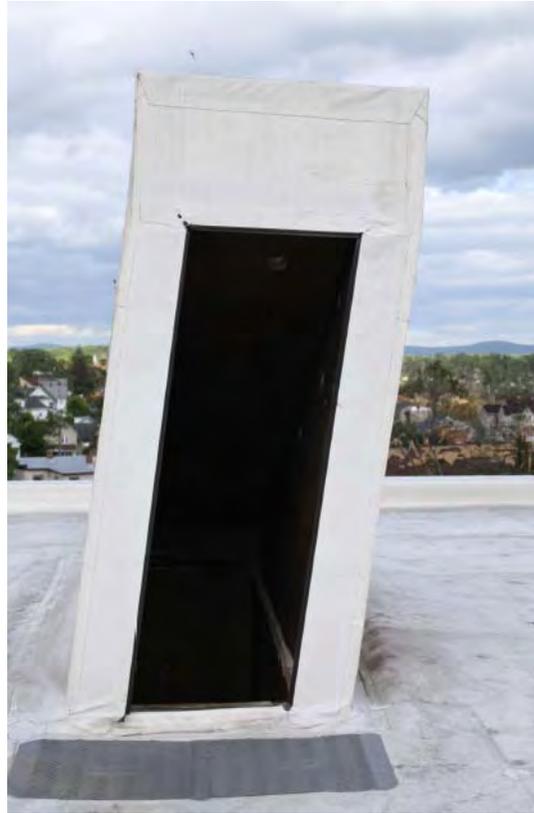
Structurally damaged stair enclosure.

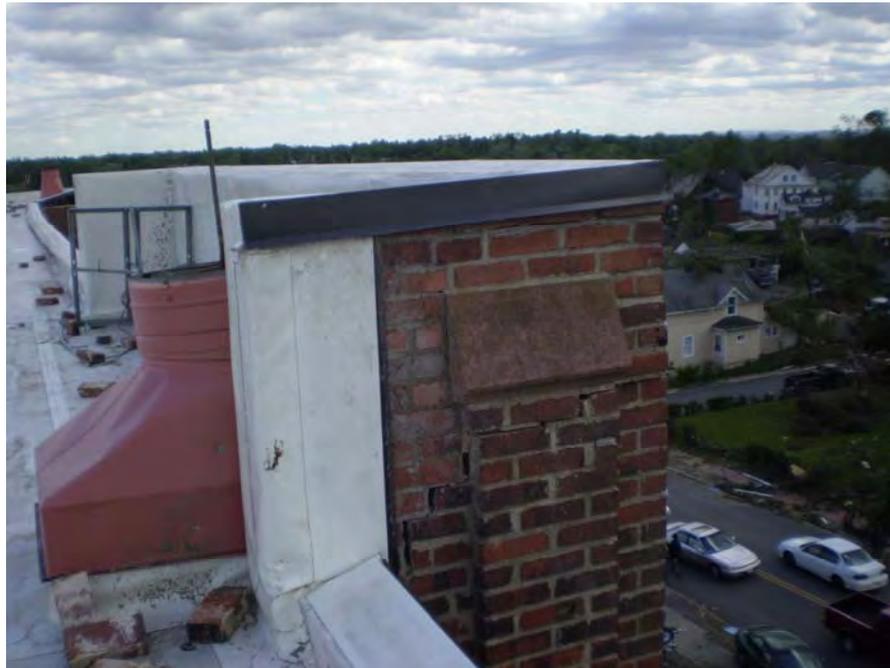
Damaged parapet and blown off roof fan.

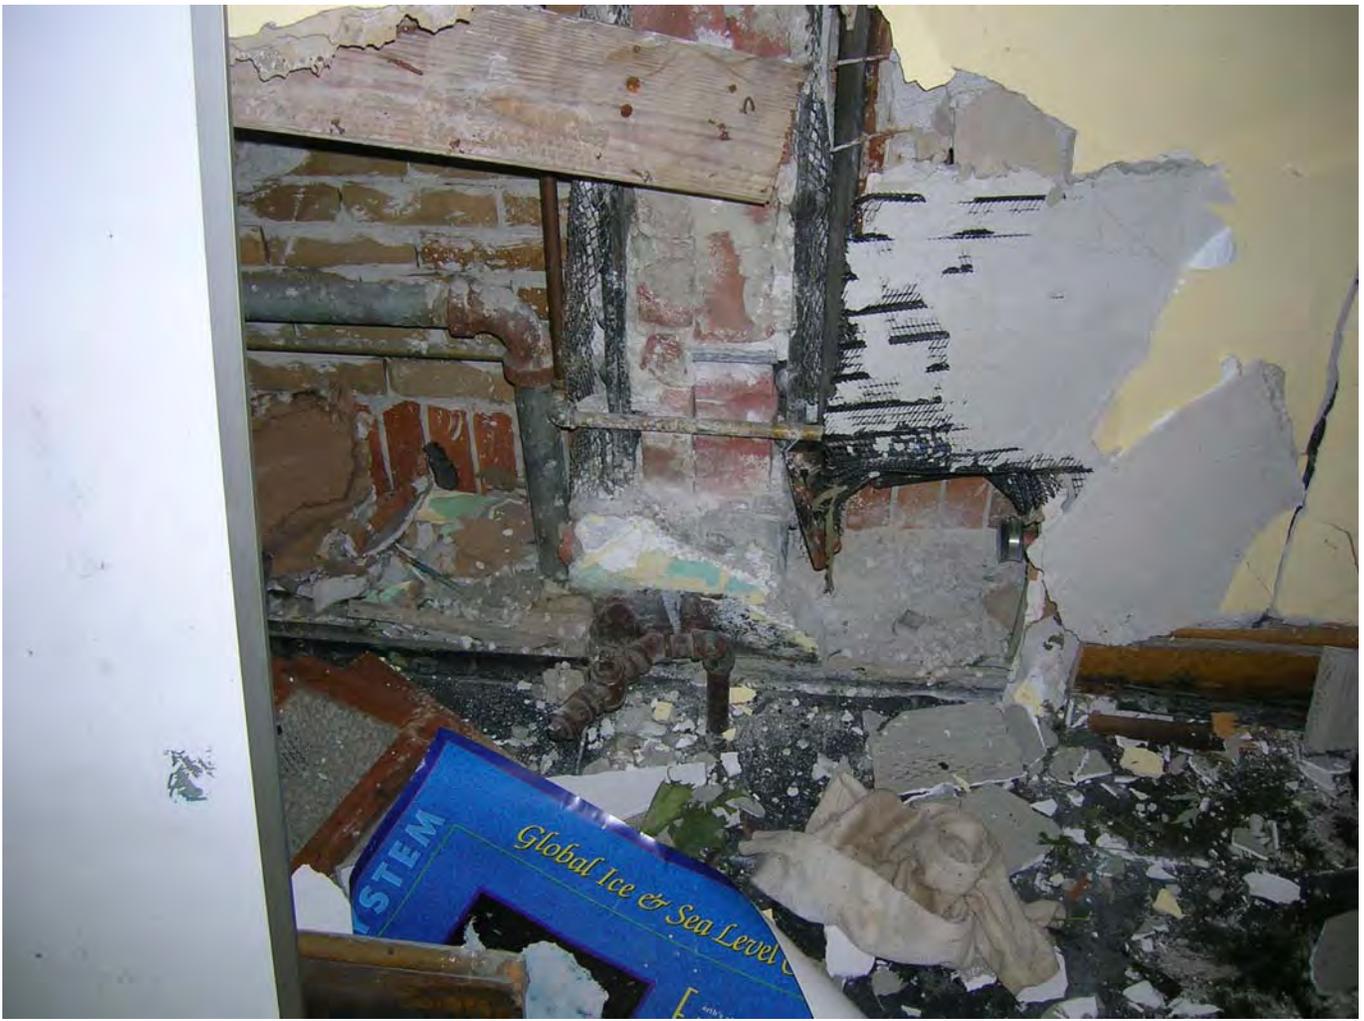
- c. Visible damage that may have affected the plumbing systems was observed within the building at various interior walls, which buckled or fell. This resulted in exposed plumbing systems specifically gas, water, waste and vent piping. The existing piping systems in these areas also appear to be intact. The water piping did not appear to be leaking and there seemed to be no smell of sewer gases present. Due to the gas service being turned off the extent of any damage to the gas piping system could

Figure 1 Piping risers in wall at damaged wall area

- 1) The existing gas piping system is to be subject to some pressure tests to verify that no leaks exist and to identify the extent and quantity of repairs that may be necessary. The entire roof drainage, sanitary waste and vent systems should also be smoke tested to determine the extent and quantity of repairs that may be necessary. The existing domestic water piping appears to be functional as no leaks appeared to be present during the walk through, along with the fact that the piping is installed below the floor. The existing sump pumps need to be energized to prevent any additional water damage to the equipment in the mechanical room.

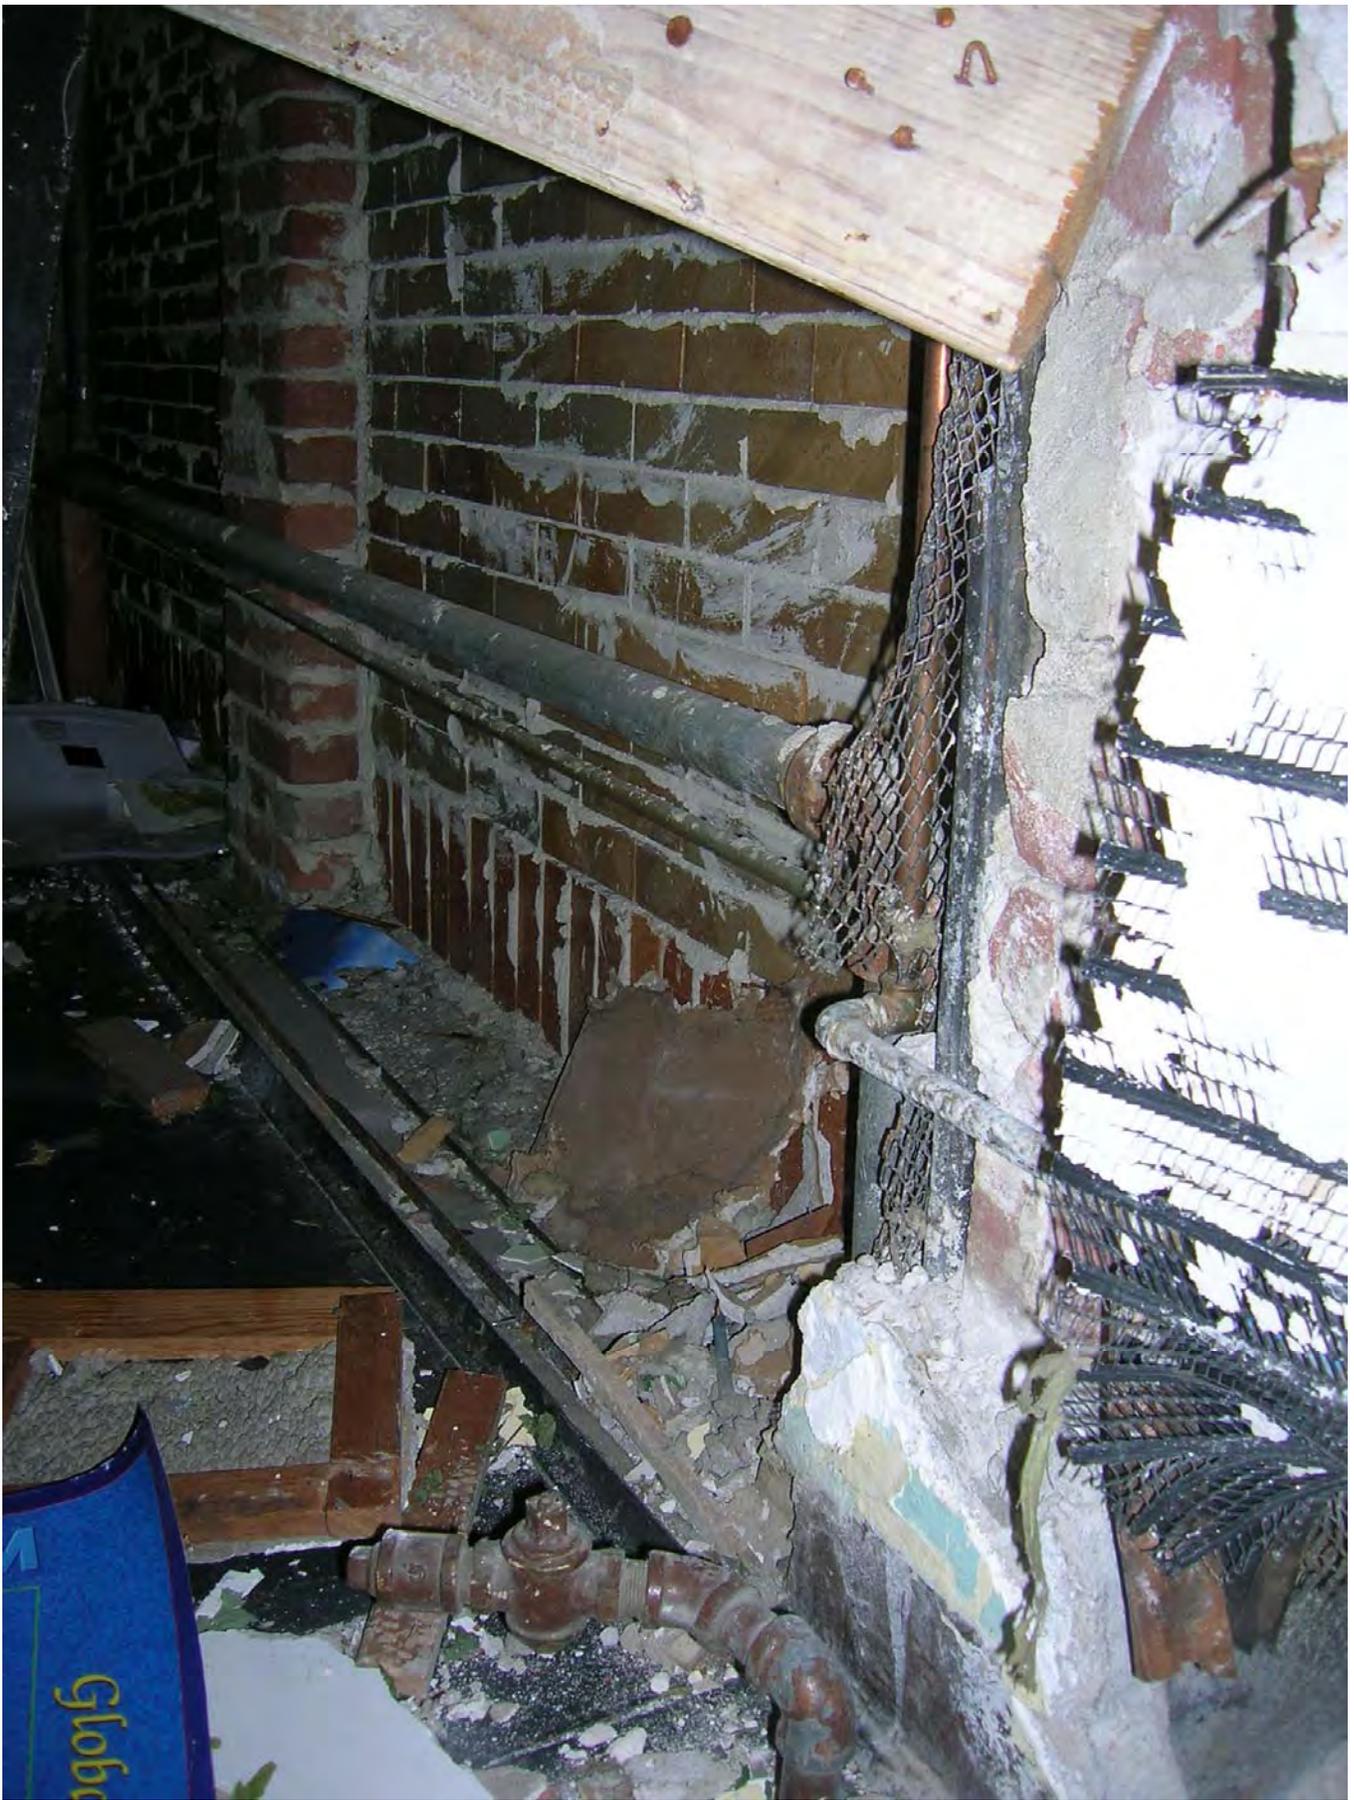
Figure 2 Horizontal piping in damaged wall

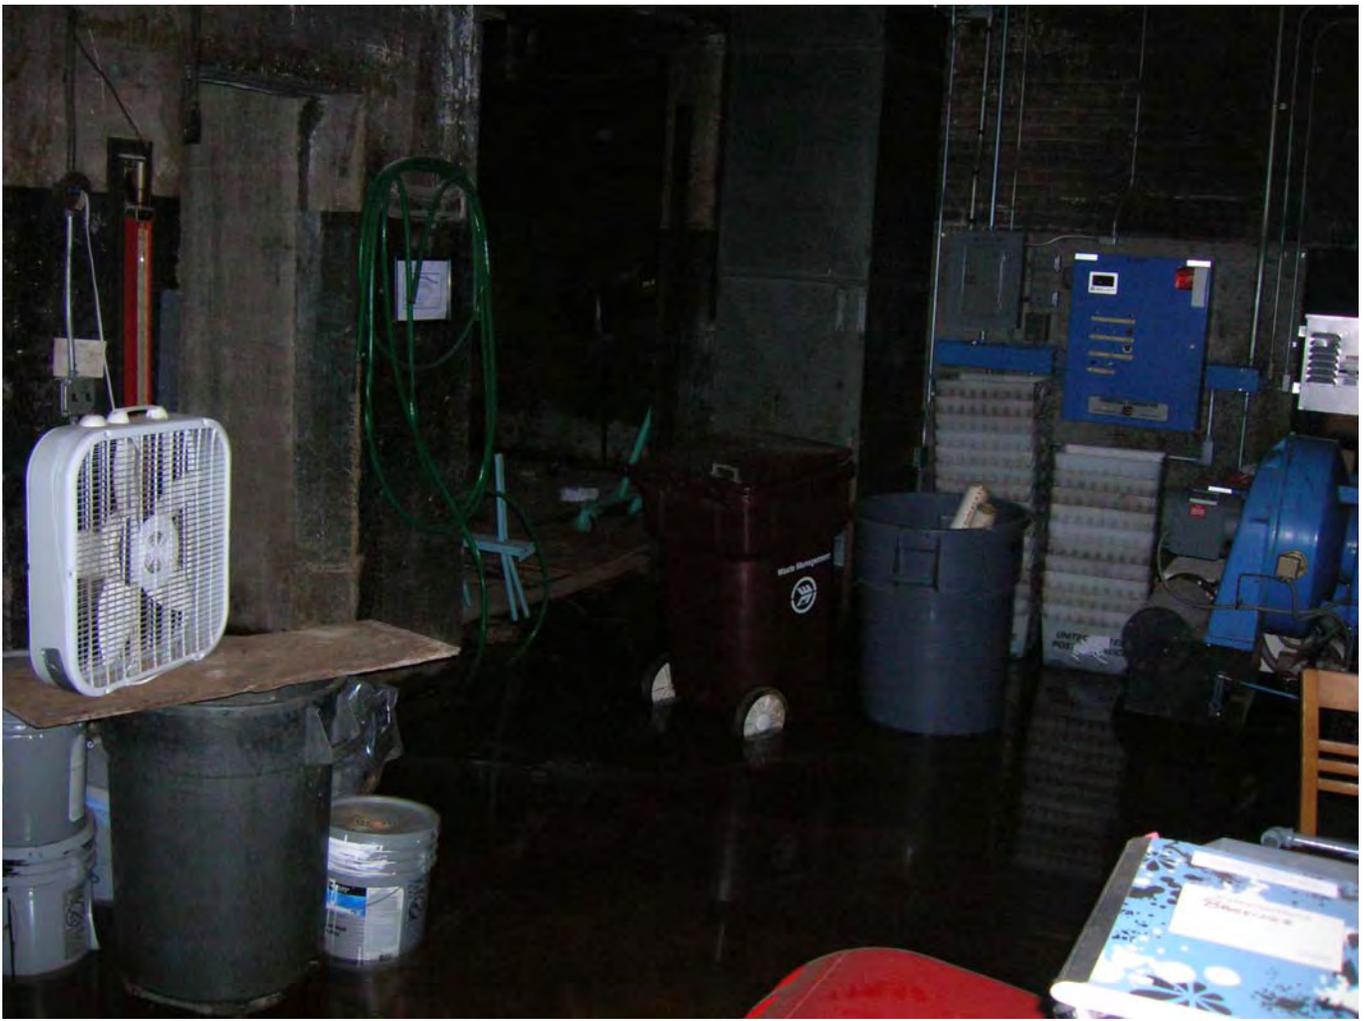
- d. It is also not known if this system is operational all the equipment is still in place. The basement mechanical room has a sump pump for ground water control, the basement floor was covered with approximately 1" of water during the time of our visit. The standing water appeared to be from ground water. The existing pump should be activated and the extent of any water damage or source of water if not ground water can then be further investigated.

Figure 3 Basement flooding

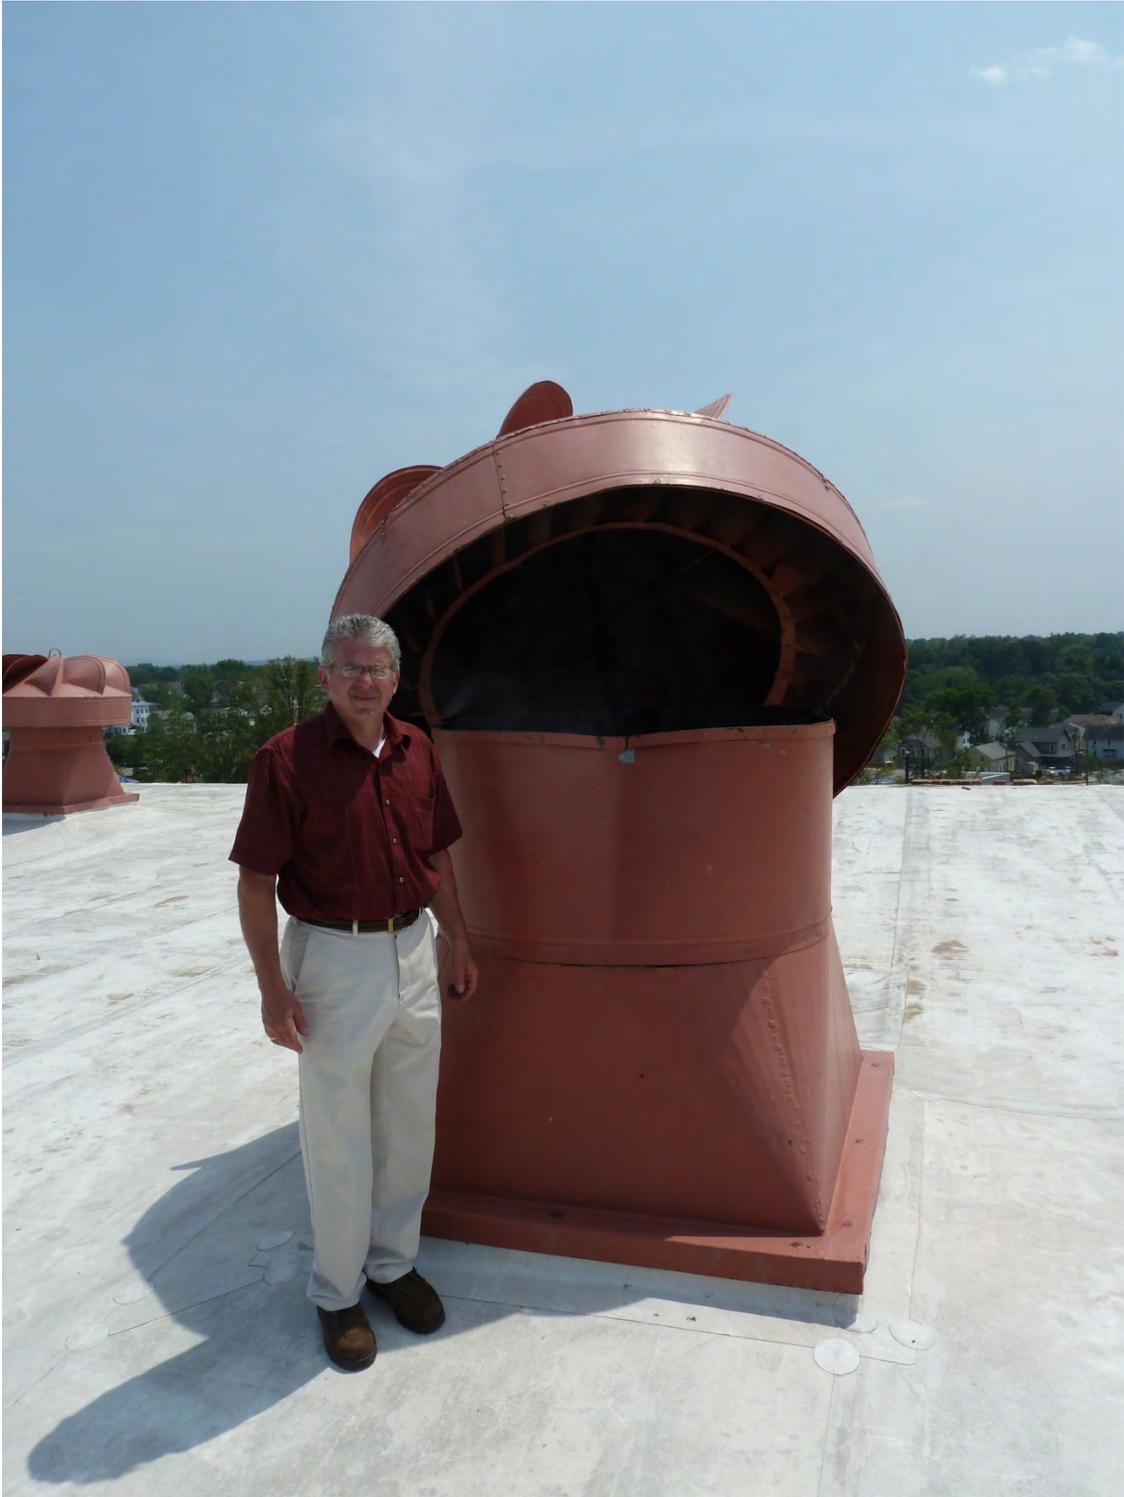
- a. The entire roof of the school seemed to shift and all six large gravity ventilators that were located on the roof were impacted. They all experience damage from being ripped entirely off the roof to partial destructions. None of these units are salvageable. Interior walls crumbled and failed to various degrees. Steam piping and some ATC pneumatic lines as well as possibly some exhaust risers are located in these destroyed walls so there may be possible damage to these pipe systems. Most of the HVAC equipment (various condensing units) that were located on the roof were displaced by the tornado winds and will most likely need repair or replacement.

Figure 6: Damaged Roof Vent on roof

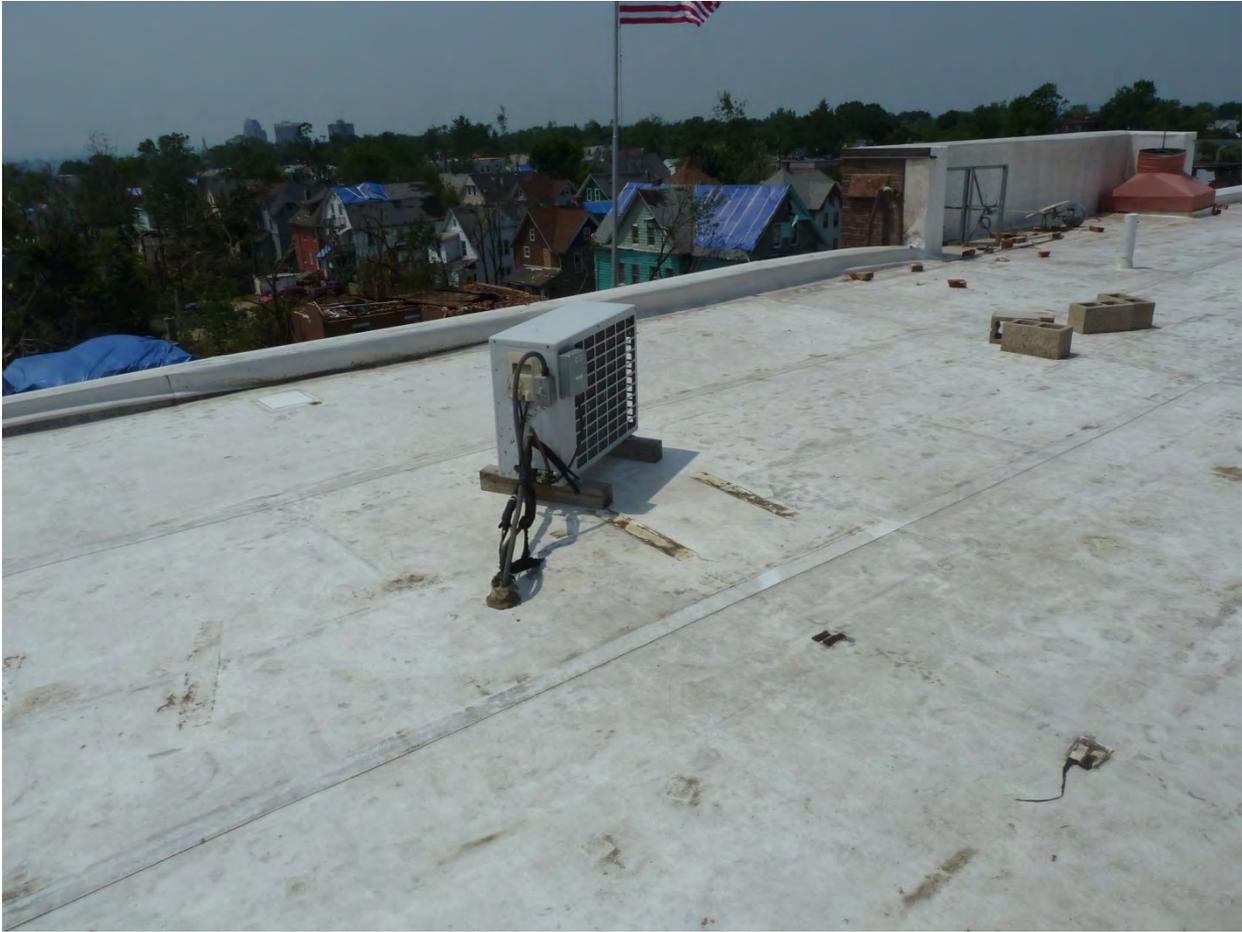
Figure 7: Shifted Condensing Unit on roof

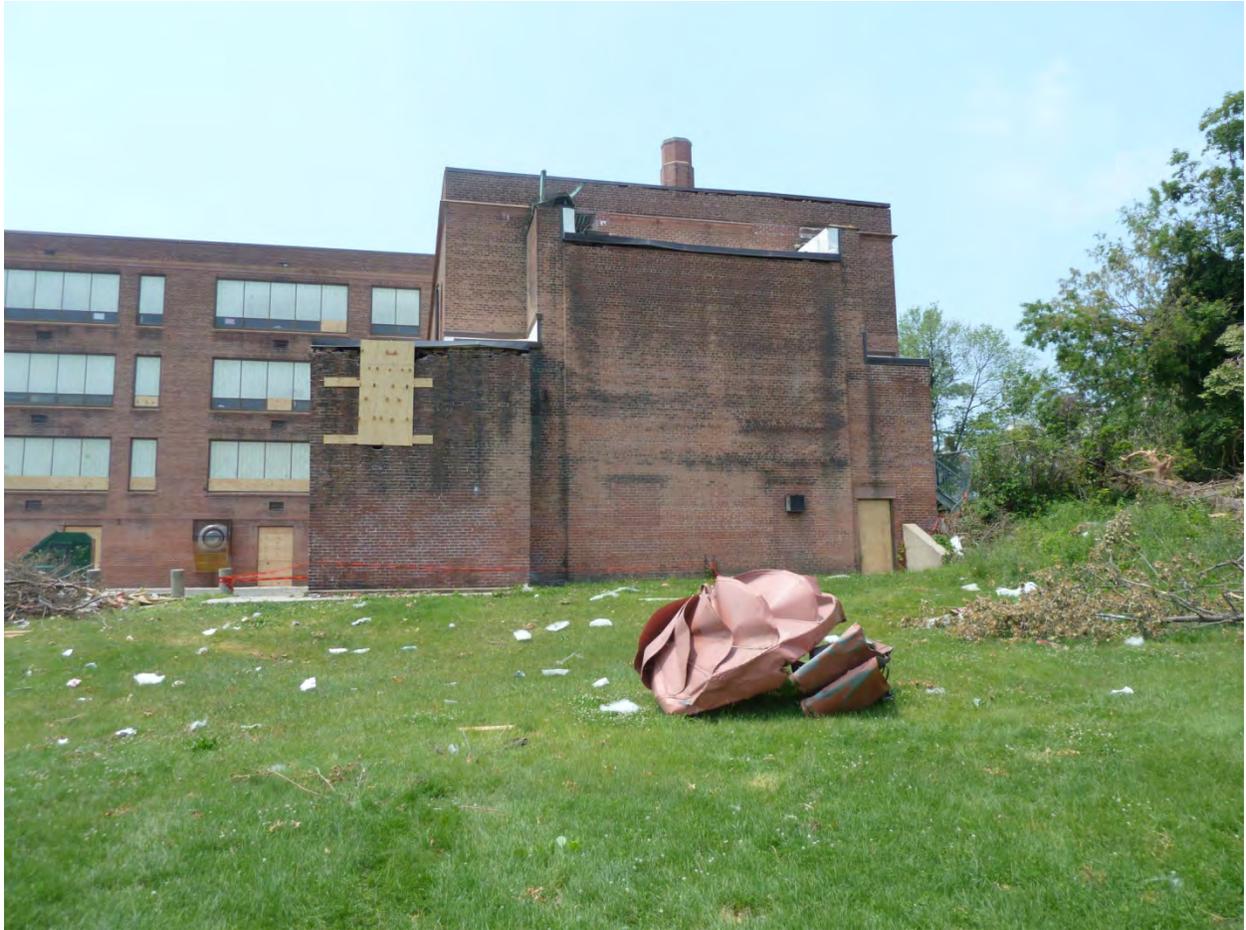
Figure 8: Roof Vent in adjacent field

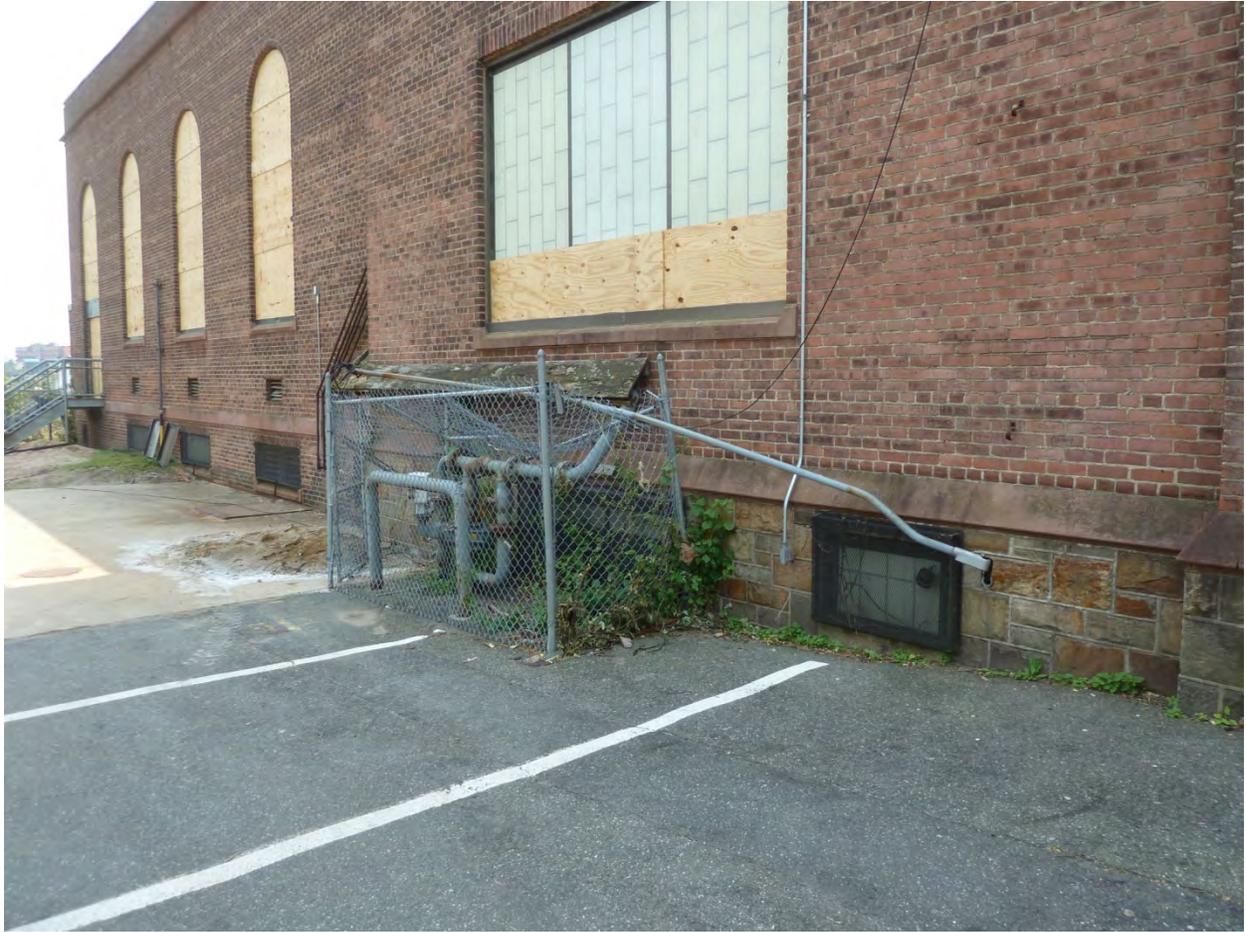
Figure 9: Gas service with Telephone Service disconnection from wall

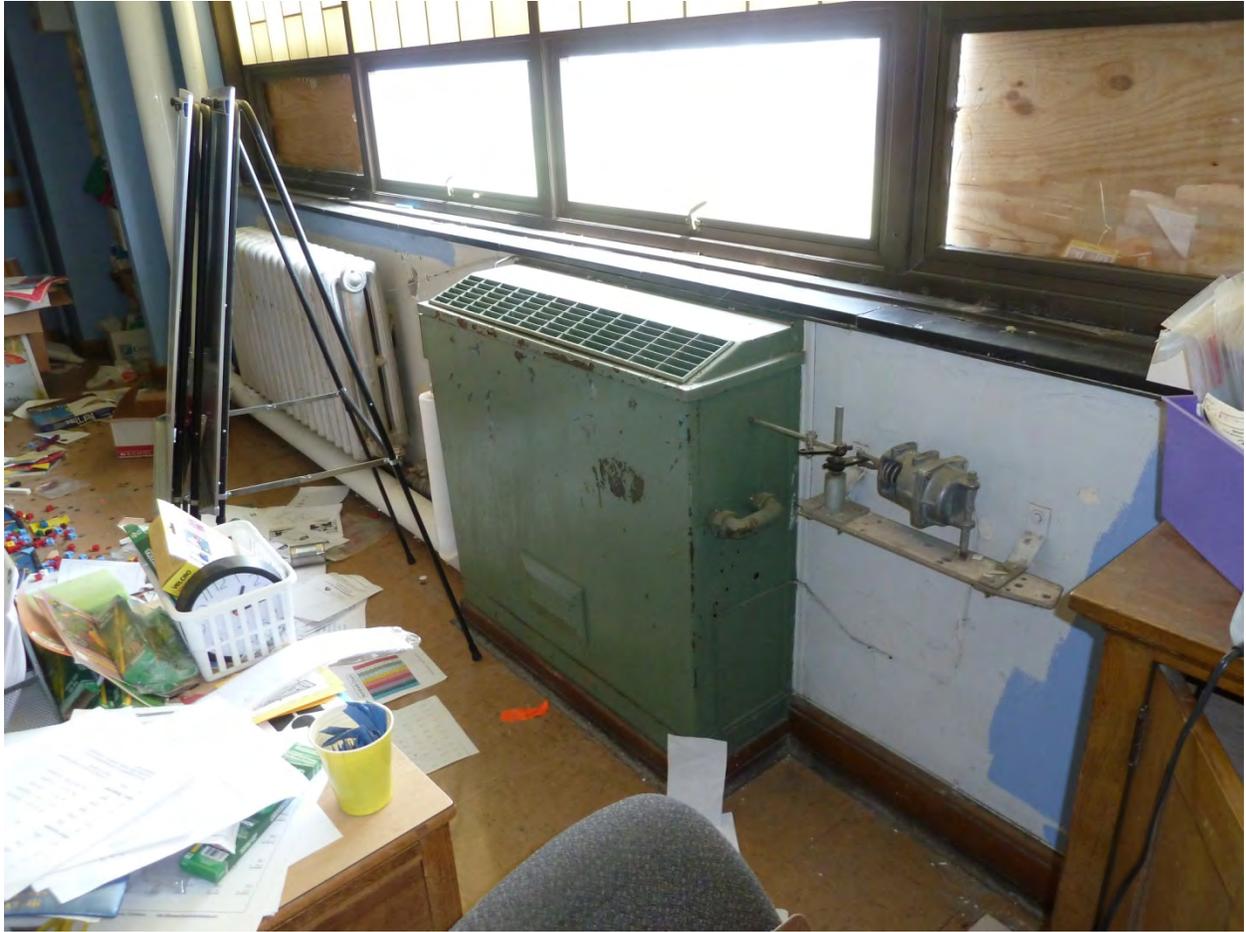
Figure 10: Exterior wall exposed cast iron radiator and Induction Unit serving classroom

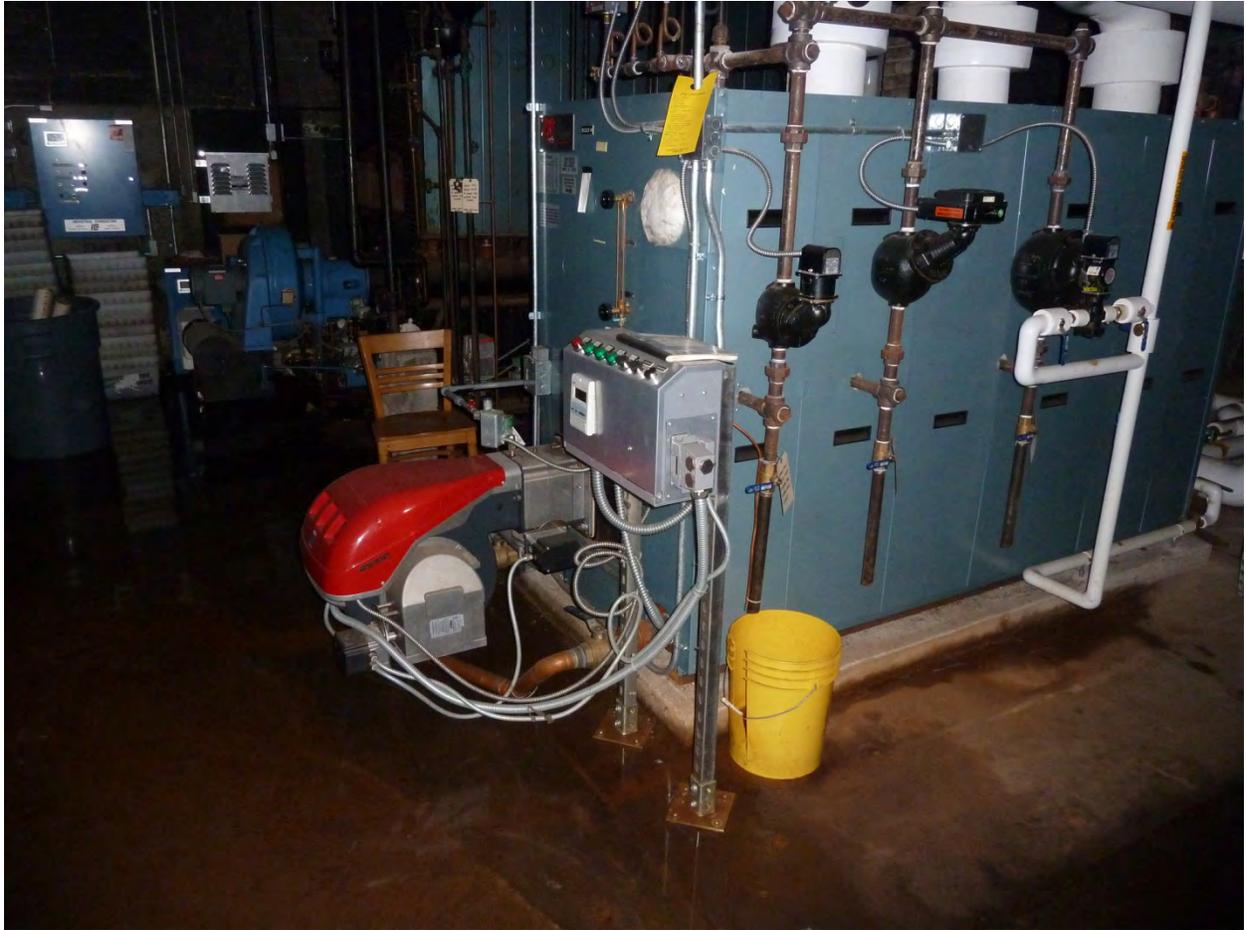
Figure 11: New Boiler/Burner in Flooded Basement

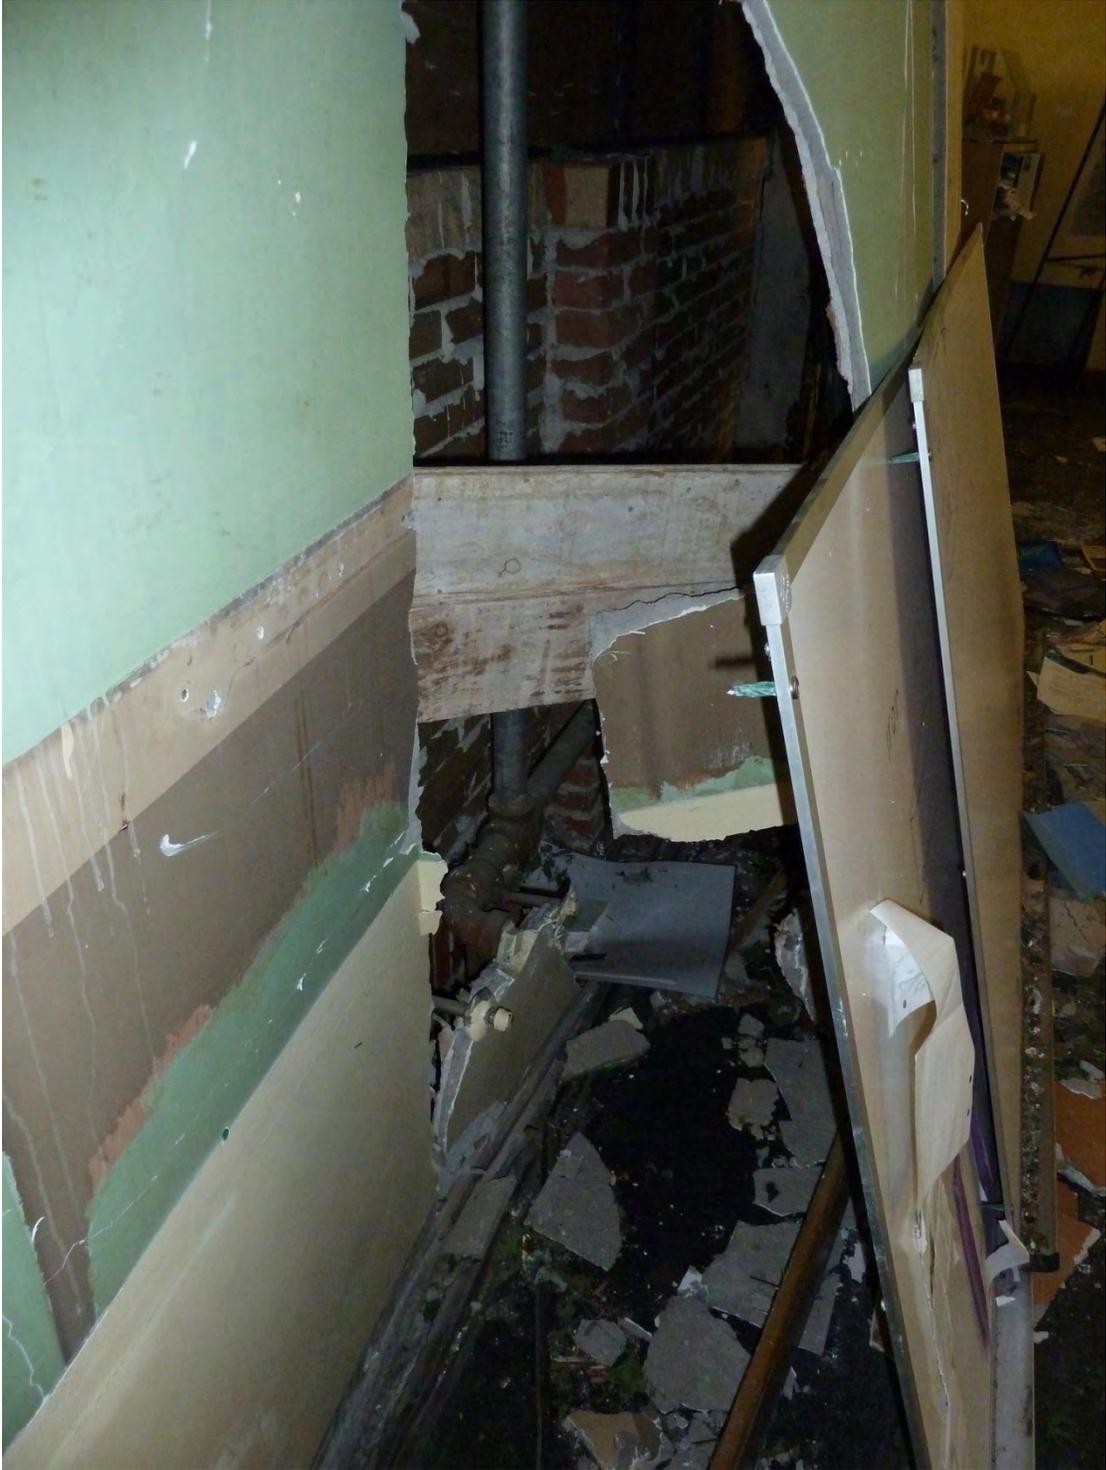
Figure 12: Collapsed Interior Wall with Pipes exposed
