Elias Brookings School

Springfield, Mass

Emergency Damage Assessment

Re: Damage Investigation of Elias Brookings Expeditionary Learning Museum Magnet School
EDG Project Number: 2011-054

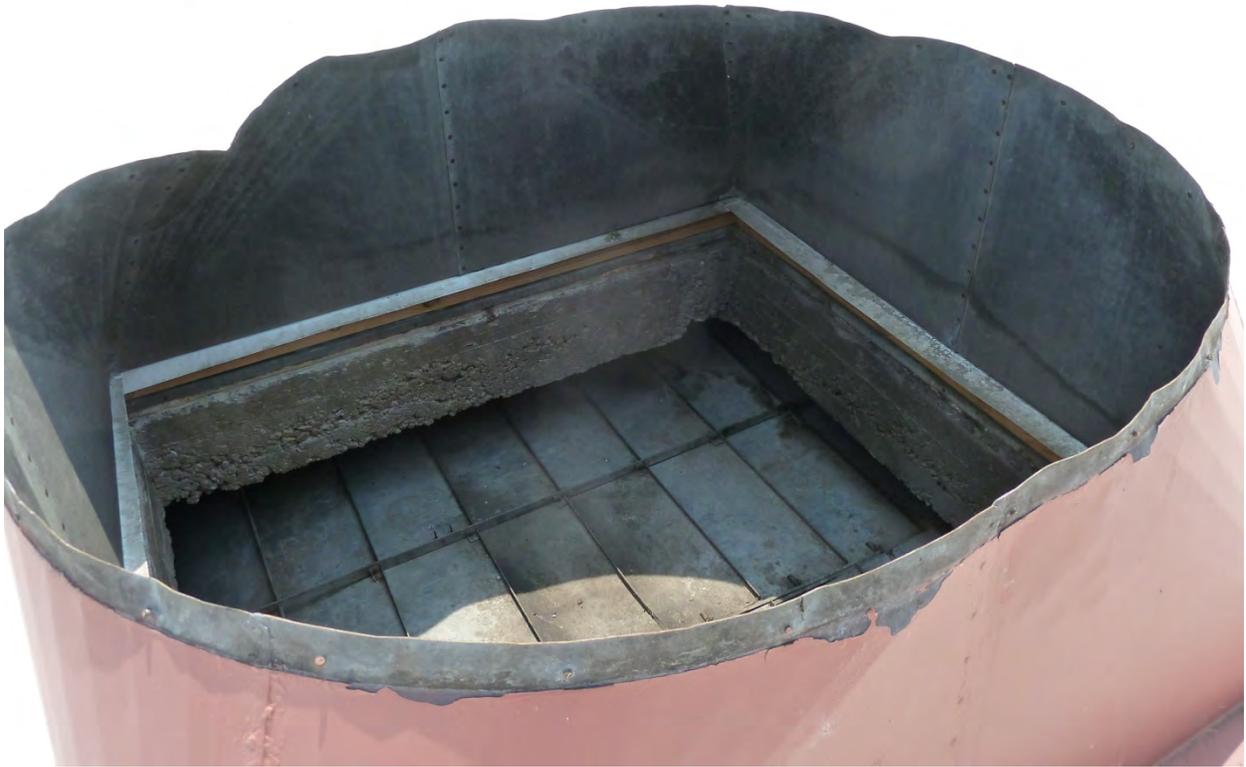
Figure 13: Torn off Roof Vent with opening through roof and exposed damper

- a. The steam and condensate piping systems should be both visually inspected (where the interior walls failed) and then leak tested after obvious problems are repaired to insure its integrity for continued use. The roof vents would need to be replaced. The ATC pneumatic system would also need to be surveyed tested and all leaks repaired. All debris that may have fallen into the open roof vents would have to be removed and the vent system cleaned.
